Manhole Inspection Summary

Manhole # S33S__025MH

Insp Date: **8/29/08 11:54 AM**

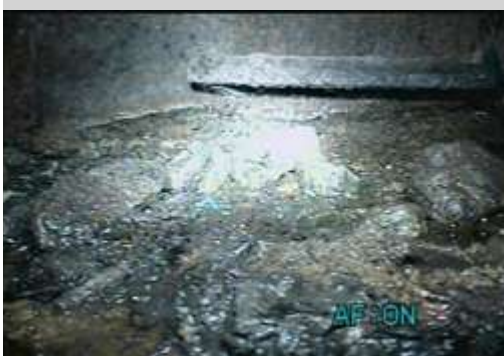
Defect 3

Bench ☒ Exists Material: **Brick** ☐ Parged

Condition: ☐ Sound ☐ Cracked ☐ Root Intrusion ☐ Deteriorated ☐ Leaks ☒ **Debris**

bench debris

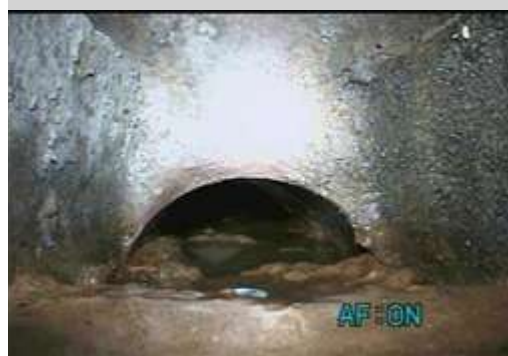
Defect 2

Channel Material: **Brick** ☐ Parged

Condition: ☐ Sound ☐ Cracked ☐ Root Intrusion ☐ Deteriorated ☐ Leaks ☒ **Debris**

Channel Debris

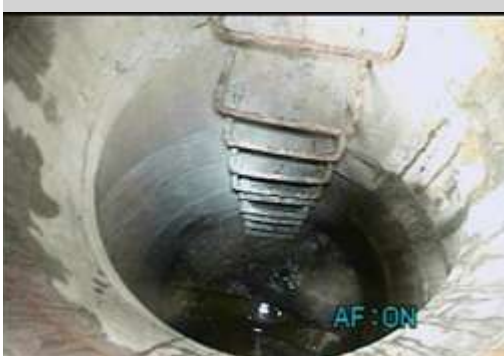
Defect 1

Steps Count: **10** Missing: **0** ☒ **Corroded**

corroded steps

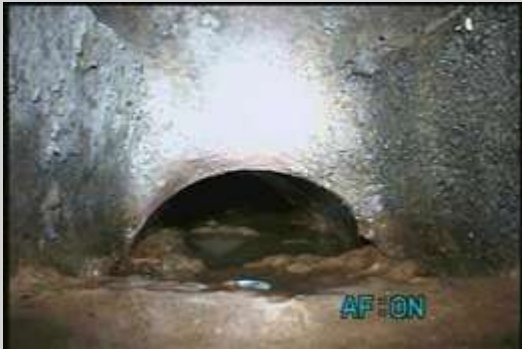
12 O'Clock Outflow

8 in. Circular Gravity Sewer
Pipe Out @ 12 O'Clock

Pipe Material: **Clay** ☐ Pipe Lined

Invert Depth: **11.92** (ft.) Flow Characteristics: **Slow**

Deposits: ☐ None ☐ Mud ☒ **Sludge** ☐ Debris ☐ Grease

Silt Depth: **3** (in.) Deposits Extent: **Light**

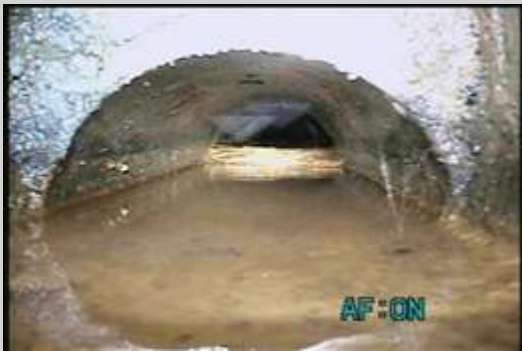
6 O'Clock Inflow

8 in. Circular Gravity Sewer
Pipe In @ 6 O'Clock

8" pipe looks bigger but we measured 3 times to make sure

Pipe Material: **Clay** ☐ Pipe Lined

Invert Depth: **11.83** (ft.) Flow Characteristics: **Slow**

Deposits: ☐ None ☐ Mud ☒ **Sludge** ☐ Debris ☐ Grease

Silt Depth: **3** (in.) Deposits Extent: **Medium**
